Permeability of Existing Structures for Terrestrial Wildlife: A Passage Assessment System

WA-RD 777.1

July 2011

Washington State Department of Transportation
Office of Research & Library Services

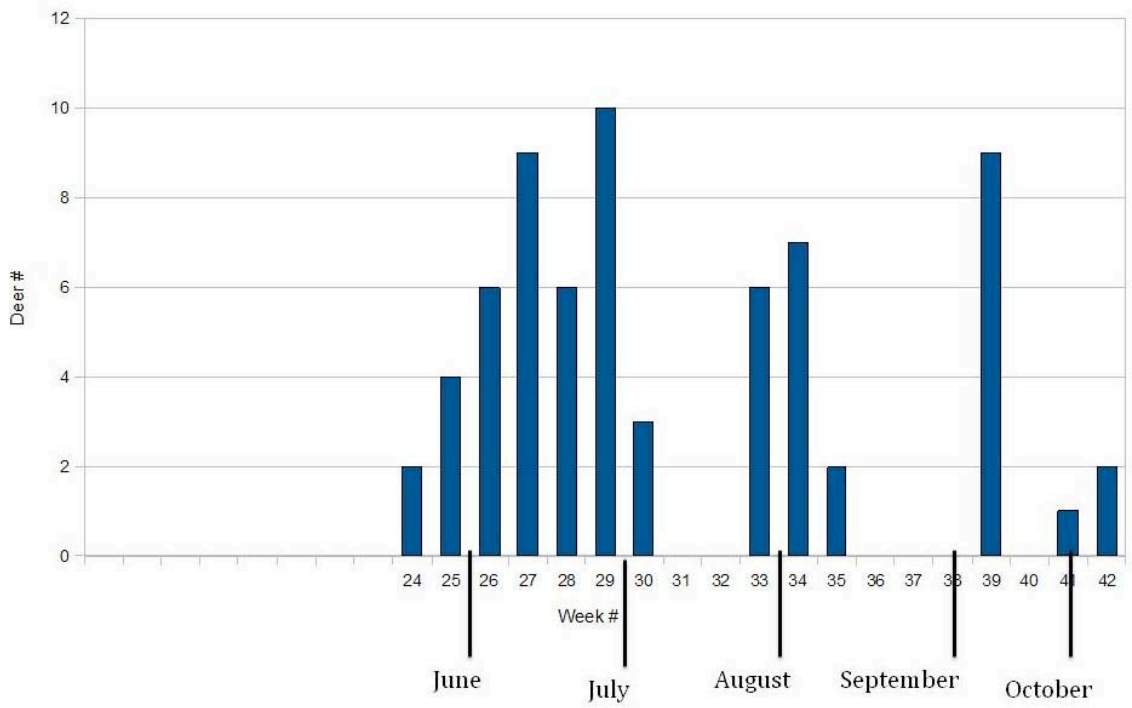
Figure 5. Black-tailed deer passes through culvert per week at US 101 Mosquito Creek culvert over the weeks of monitoring in 2010.

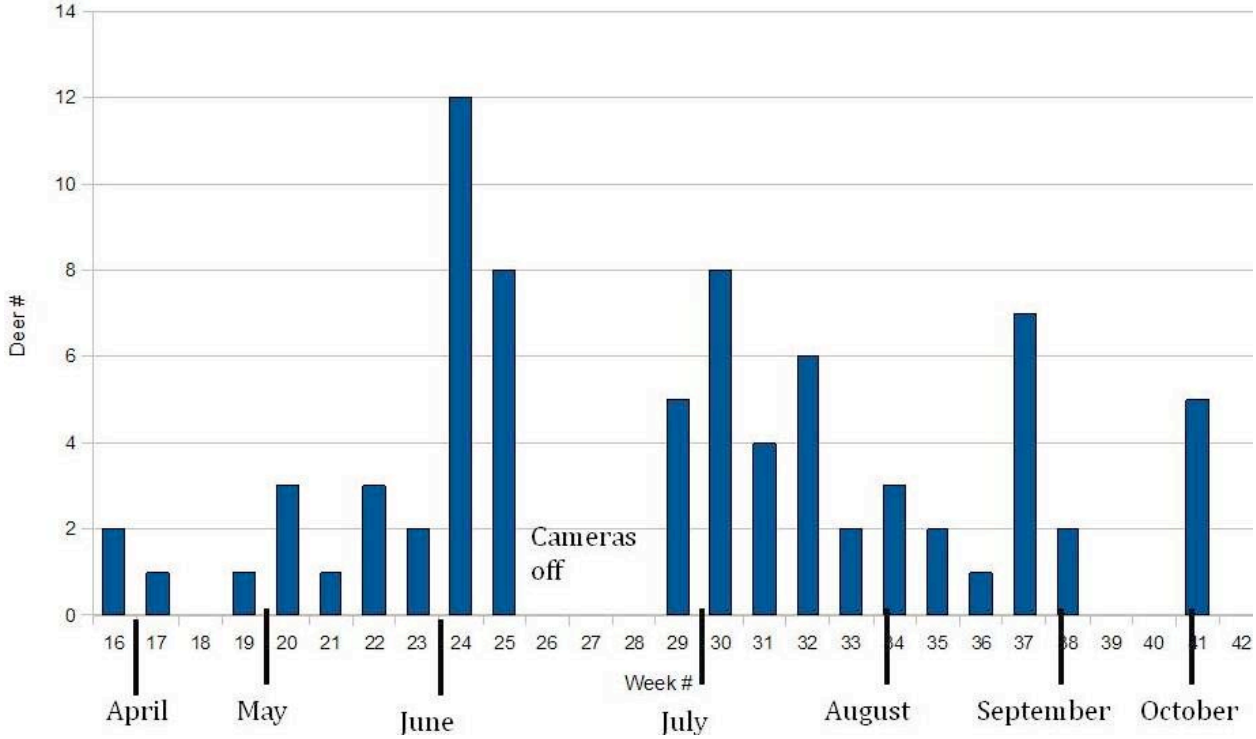
Figure 34. Black-tailed deer observations per week at SR 6 Willapa River Bridge over the weeks of monitoring in 2010.

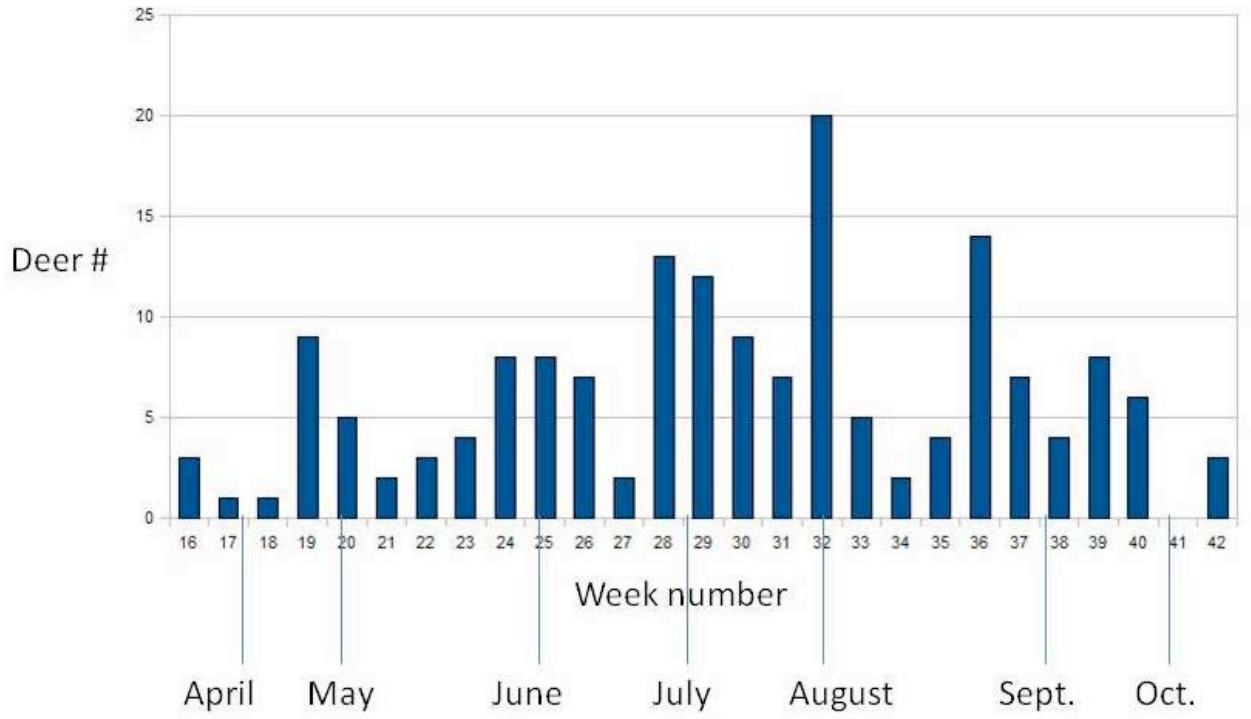
Figure 89. Mule deer passes per week at I-90 Cle Elum Bridge over the weeks of monitoring in 2010.

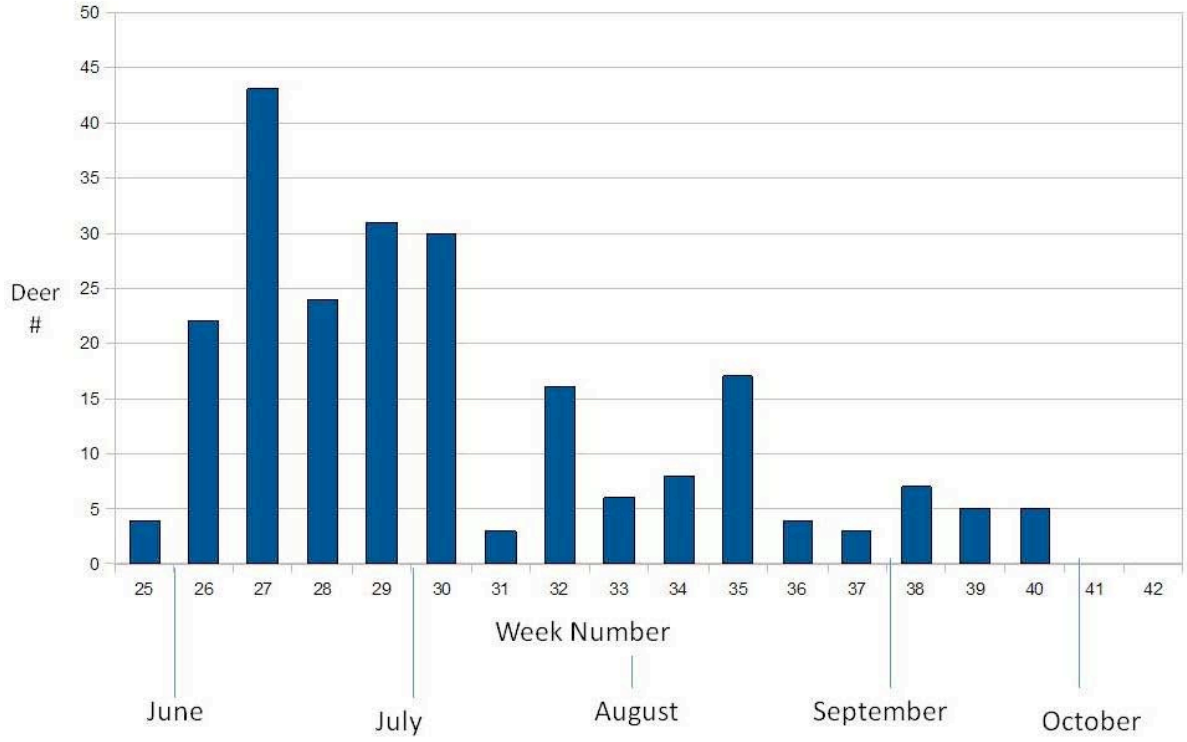
Figure 101. Mule deer passes per week at I-90 MP 73 box culverts over the weeks of monitoring in 2010.

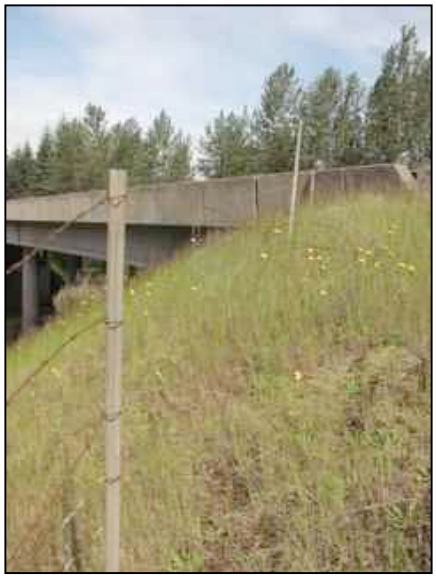
Figure 111. Large gap in barbed wire fencing through median

- Repair gaps in fencing and escape ramps for extensive stretches of fencing.
- Improve stream bank habitat on both sides of the river. Establish a riparian access area for people and their pets away from the structure and inhibit such human/dog activity directly under the structure itself.
- Control Himalayan blackberry brambles so wildlife can move through the riparian vegetation and their movements can be separated from recreationists and dogs on the trail.
- Add soil pathways over the riprap on both sides of the river (at least one pathway under each structure and in the median).

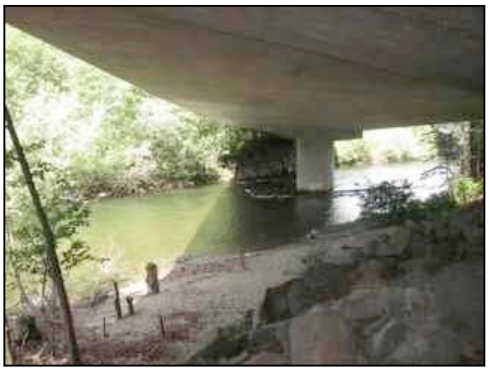
Figure 112. Beneath north structure

Recommendations
Currently, the structure is highly functional for most wildlife, although regular human activity may limit some wildlife passage. The following recommendations would enhance successful crossings:

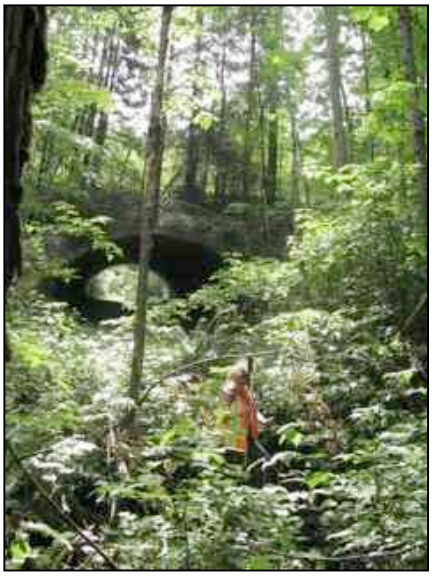
Figure 125. Thick median vegetation
